HONG KONG MERCHANT SHIPPING INFORMATION NOTE

Fatal Accident Resulting from Sudden Hook Detachment of a Lifeboat

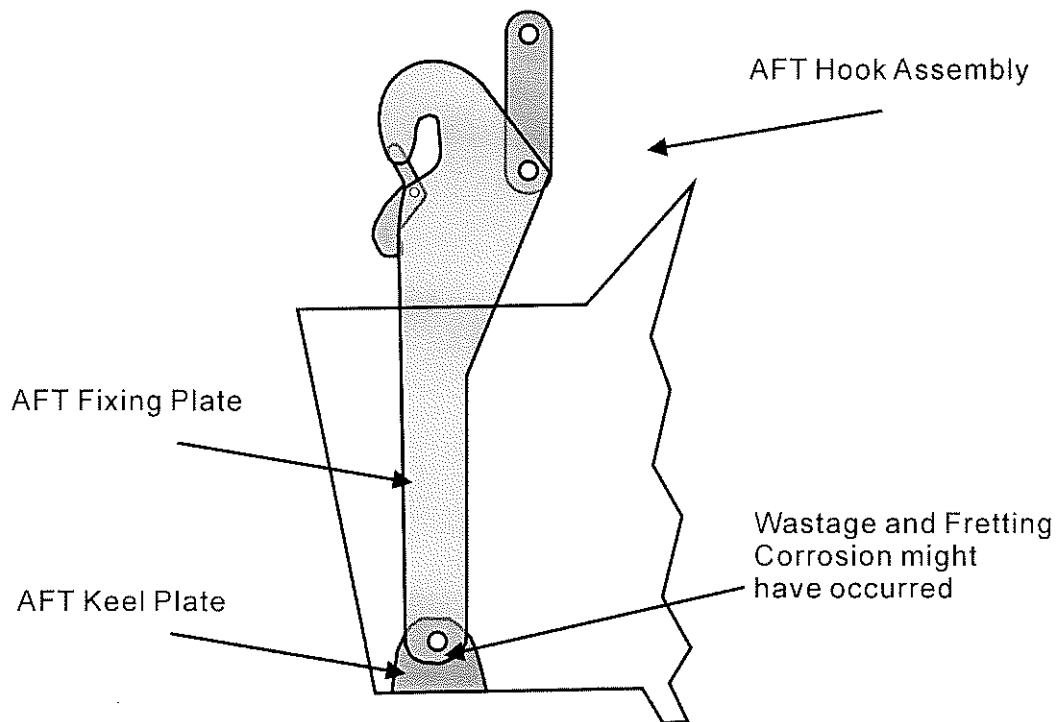
2. The investigation revealed that the cause of the accident was due to the shearing off of the fixing plates (sketch) from the lifeboat structure during launching operation. The fixing plates are used to take up the load of the lifeboat while it is in suspension. It is believed that the shearing off of the fixing plates could have caused by either:

- a. Corrosion in the form of mainly wastage and probably fretting; or
 - b. Metallic defects

Excessive Corrosion at Contact Surface of the Securing Bolt and the Lower Part of the Fixing plates

3. The lessons learnt from the incident are as follows:
 - (a) The lifeboats are stowed on davits without resting on chocks. As a result, the lifeboat hook assemblies and the fixing plates are always subject to heavy and fluctuated stress, particularly in rough seaways. The combination of the direct and fatigue stresses would have additional loading on the aft hook assembly and the fixing plates.
 - (b) The fixing plates were housed in a glass-reinforced plastics enclosed compartment fitted with an access door. As most of the ships are invariably sailing in a trimmed condition by stern, rain, seawater, or condensation could accumulate from time to time in the aft enclosed compartment, which would present favourable conditions for the corrosive process to take place.

- (c) The fixing plates of the lifeboats appeared to have not been inspected and maintained properly. However such items of inspection as part of the structure of the lifeboat are not included in the maintenance manual. The fixing plates were housed inside a compartment fitted with an access door, the crew should have opened the door to check for the condition. To improve the situation, the lifeboat maintenance manual should incorporate the checking of condition of the fixing plates as a lifeboat structure inspection items.

- (d) The fixing plates as part of the lifeboat design were manufactured by the Blue Sea Industrial Co. Ltd. in Taiwan which had been closed down. As the shearing off of the fixing plates was probably caused by wastage due to excessive corrosion, this might have been inherited from design faults or defects in the manufacturing of the lifeboat. The company should consider seeking for technical assistance from a renowned lifeboat manufacturer or the classification society to look into the structure and holding arrangement if their lifeboats were manufactured by the Blue Sea Industrial Co. Ltd. in Taiwan.
